Manhole Inspection Summary

Manhole # S41SS_025MH

Location Address: **2642 KIRK AVE** Cross Street: **MONTPELIER ST**

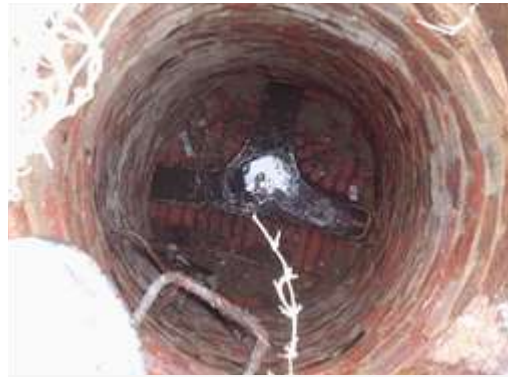
Top View

Corbel and Barrel infiltration. Corroded steps. Evidence of surcharge - Bench debris. Channel debris.

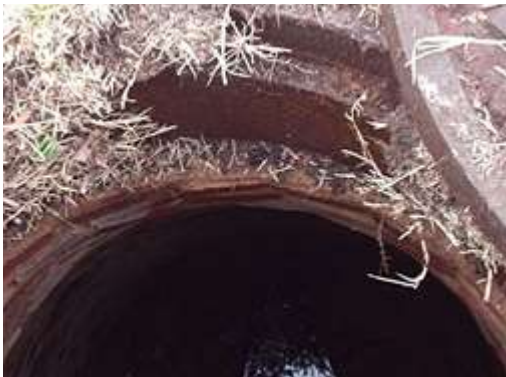
Defect

Frame leaks. Frame offset. Adjustment infiltration.

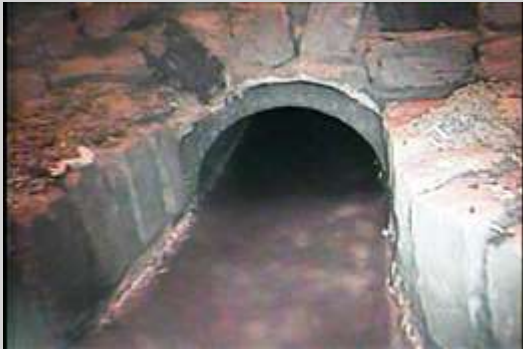
8 in. Circular Gravity Sewer Pipe Out @ 12 O'Clock

Pipe Material: **Clay** ☐ Pipe Lined

Invert Depth: **9.95** (ft.) Flow Characteristics: **Slow**

Infiltration: **None** Pipe Seal Cond: **Sound**

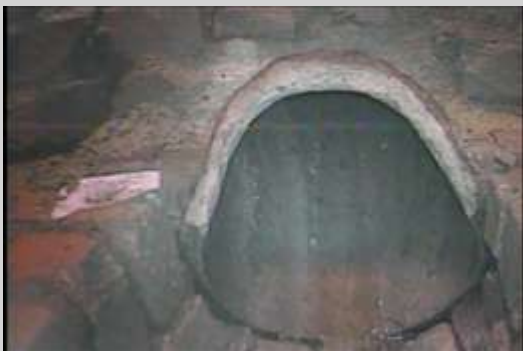
8 in. Circular Gravity Sewer Pipe In @ 3 O'Clock

Pipe Material: **Clay** ☐ Pipe Lined

Invert Depth: **9.57** (ft.) Flow Characteristics: **Slow**

Infiltration: **None** Pipe Seal Cond: **Broken**

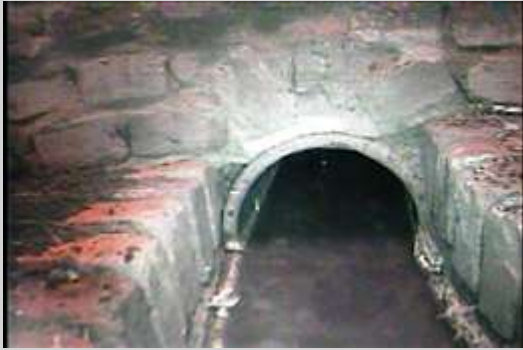
Pipe In @ 9 O'Clock

Pipe Material: **Clay** ☐ Pipe Lined

Invert Depth: **9.87** (ft.) Flow Characteristics: **Slow**

Infiltration: **None** Pipe Seal Cond: **Sound**
